Snow Avalanches Along Colorado Mountain Highways

by Hans Frutiger

ROCKY MOUNTAIN FOREST AND RANGE EXPERIMENT STATION

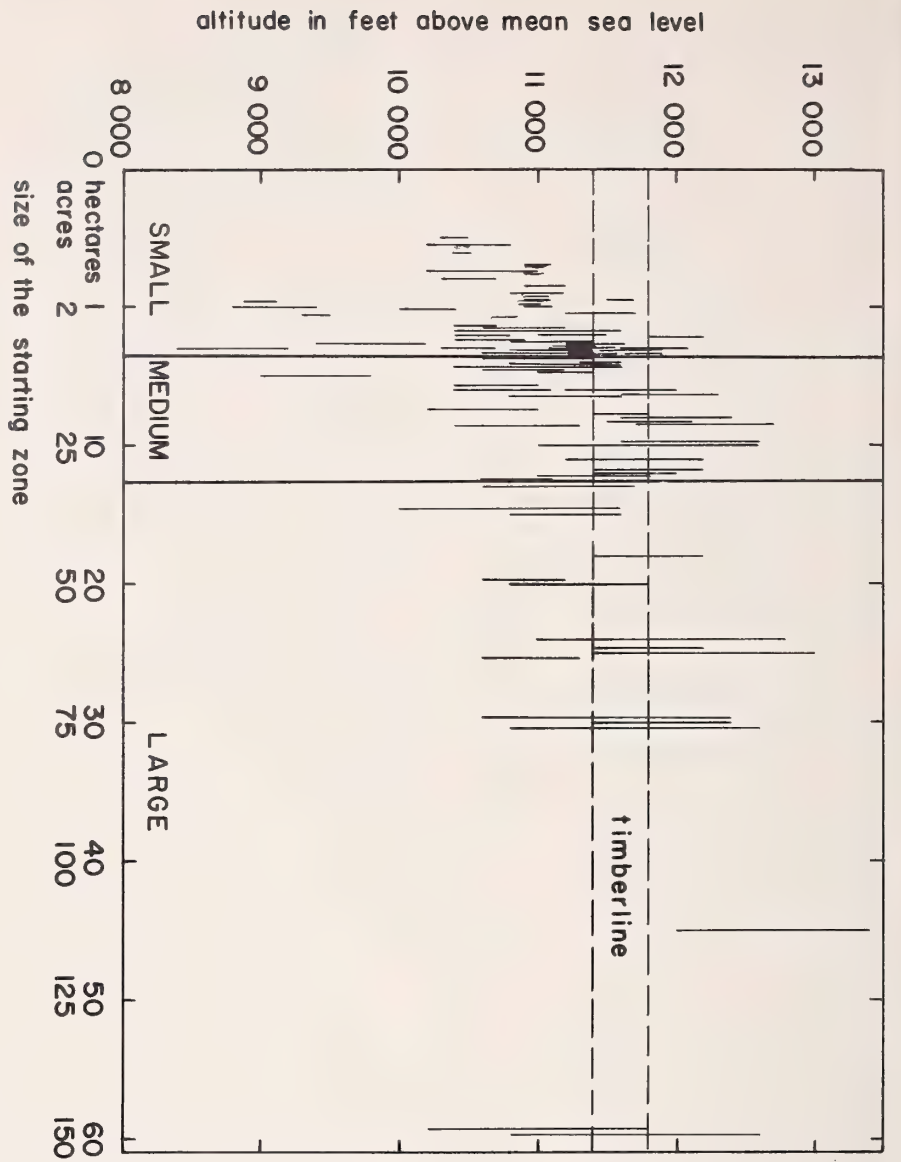
Figure 1.--Size and altitude of the starting zone of 80 avalanches in four mountain passes in Colorado, 1961-62. An expanded scale has been used for the 0- to 2-acre classification.

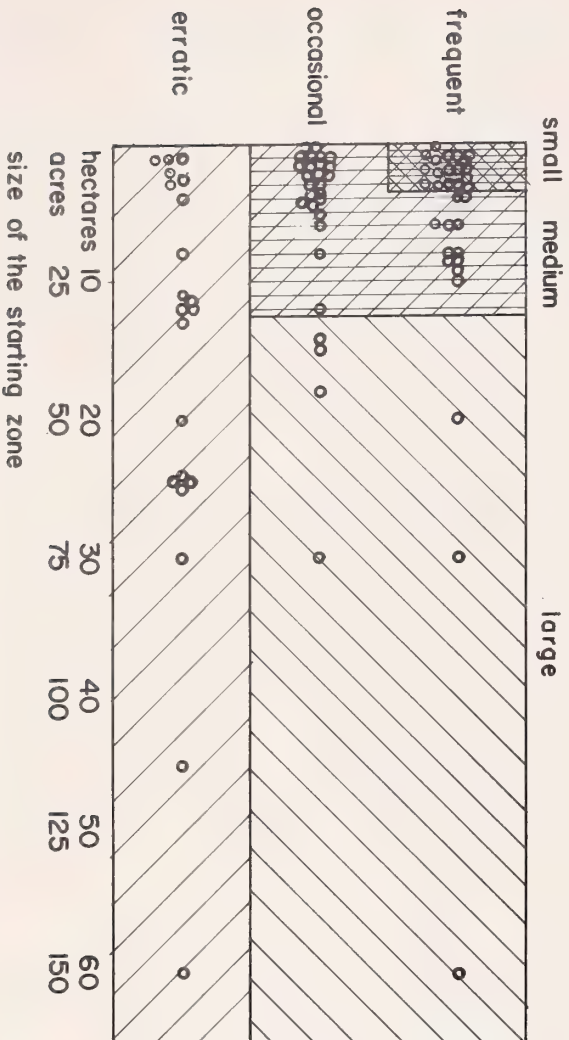
Figure 2.--Frequency of occurrence and size of 80 avalanches in four mountain passes in Colorado, 1961-62. Frequency classifications--erratic, occasional, and frequent--refer to how often the avalanches reach the highway. The size classifications--small, medium, and large--refer to the extent of the starting zone; not to the amount of snow brought down by the avalanche.

Avalanches are grouped according to their significance to traffic and the possibilities of structural control (table 1, fig. 2). Group 1 consists of the small-frequent avalanches. These are very hazardous to traffic, and could be controlled with little effort. In almost all cases, supporting structures in the starting zones and afforestation are recommended.

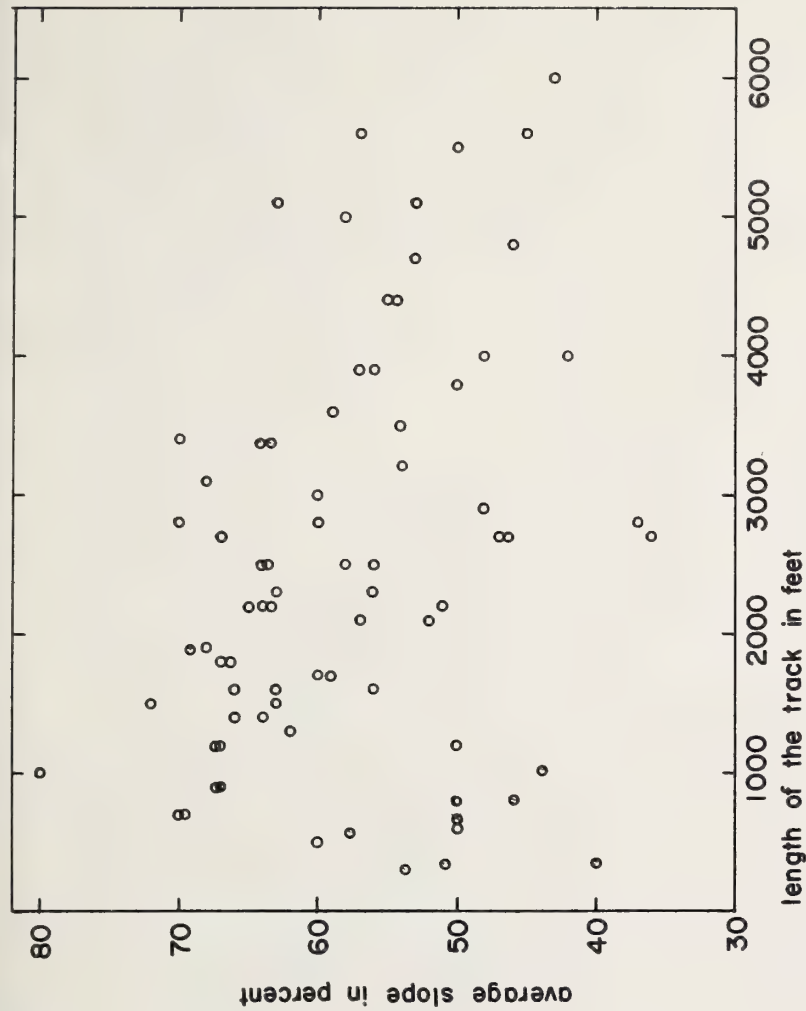
Figure 3.--Length and average slope of the tracks of 80 avalanches in four mountain passes in Colorado, 1961-62.

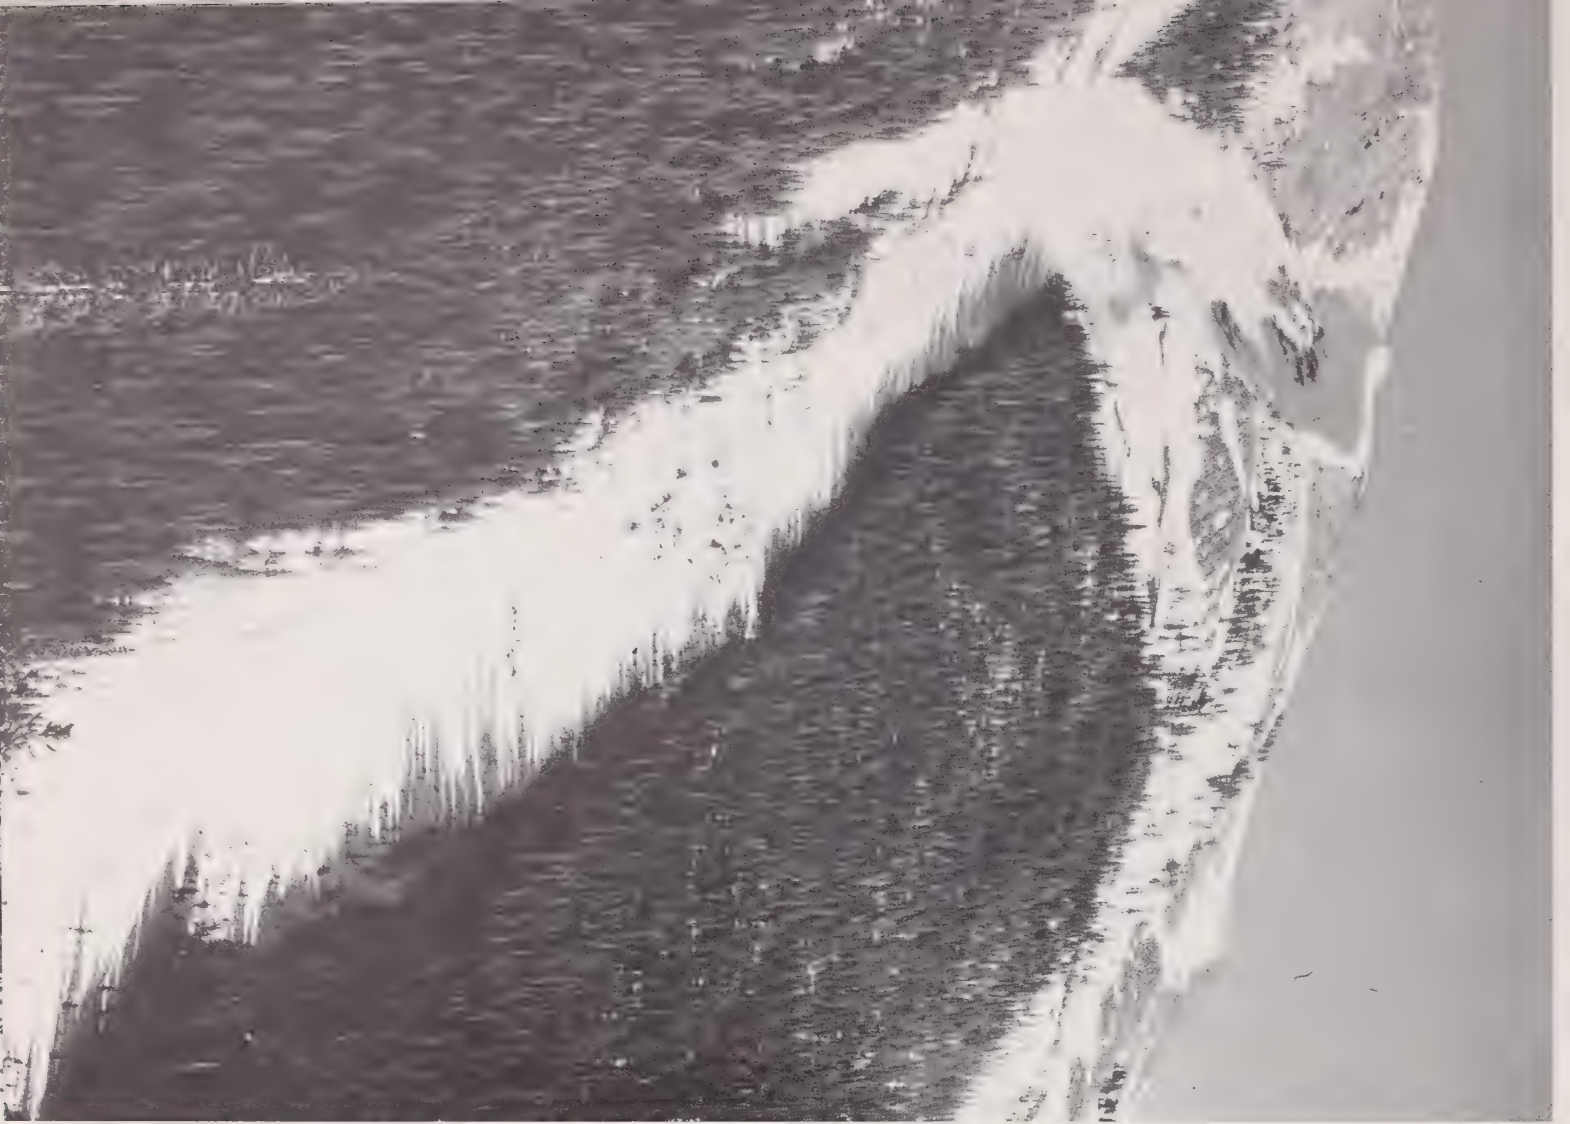
BERTHOUD FALLS (B-4)

Highway No. 40 --
Berthoud Pass
Photo: April 23, 1962

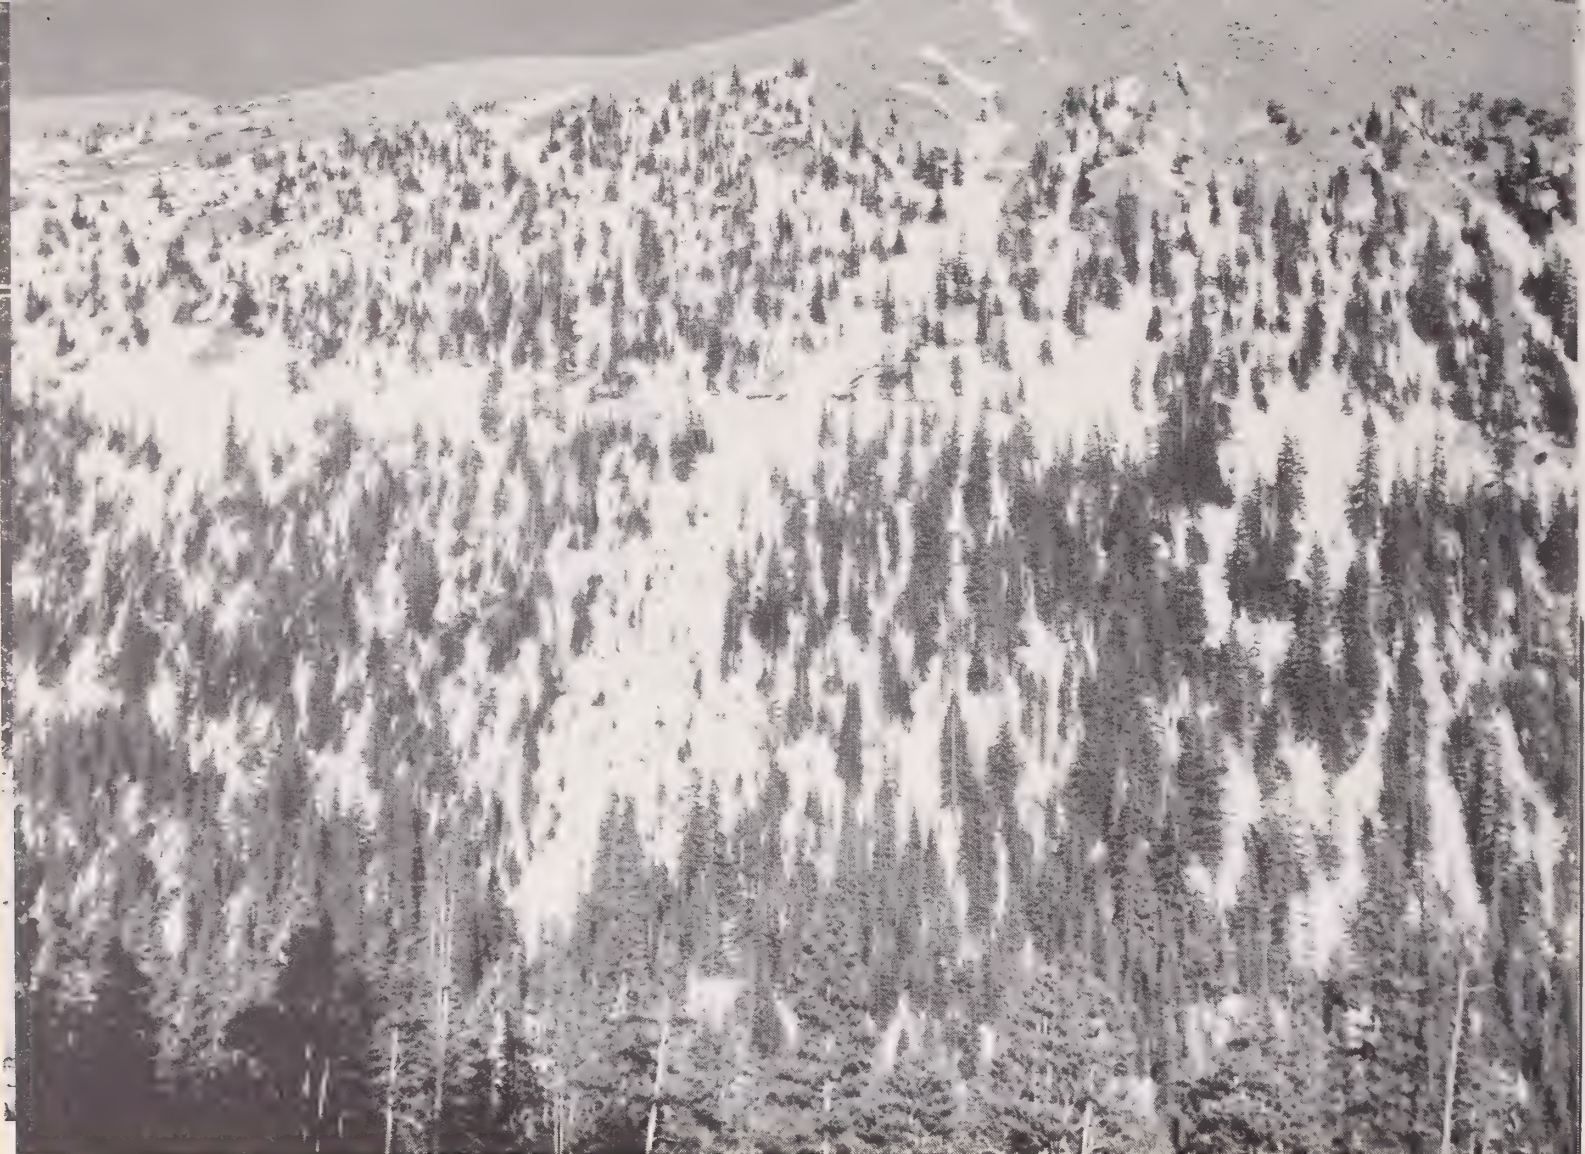
FLORAL PARK (B-6)

Highway No. 40 --
Berthoud Pass
Photo: April 23, 1962

Access is easy, so supporting structures would present no problem. Afforestation may be difficult on the talus.

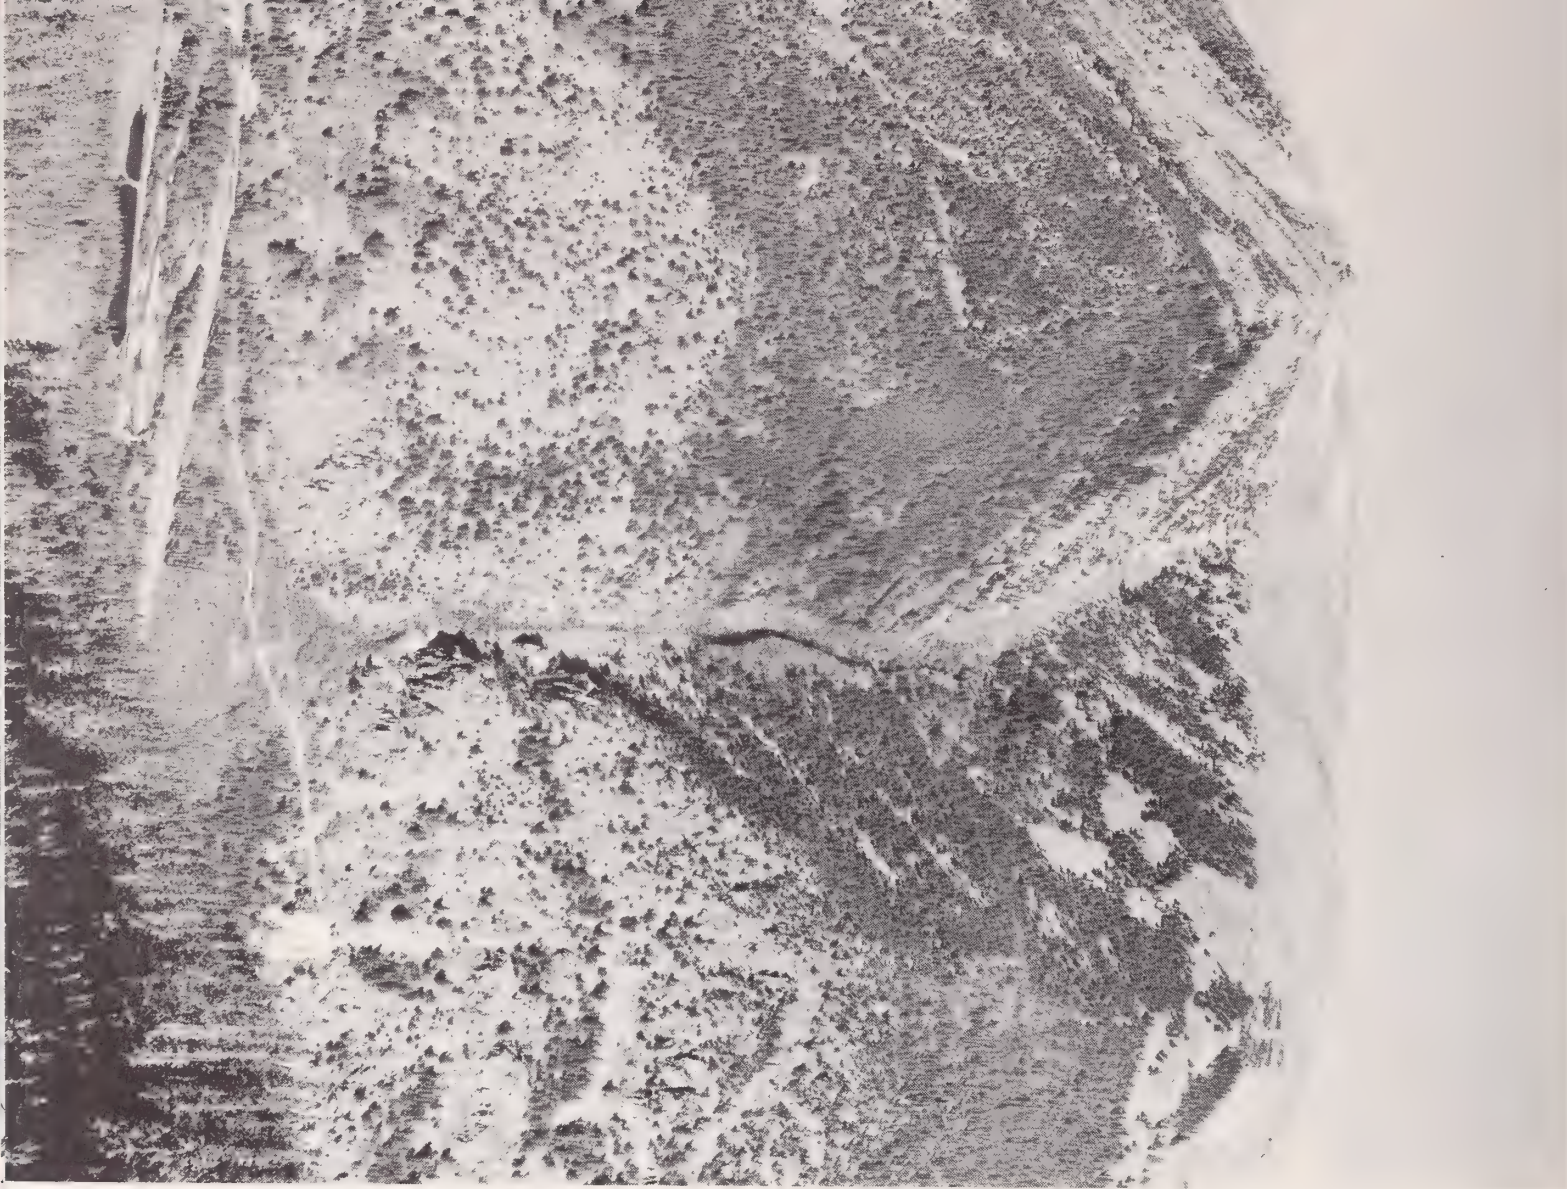
SILVER CLOUD (L-2)

Highway No. 6 --
Loveland Pass
Photo: September 1, 1962

Because it is an erratic, large avalanche, structural control seems to be not very economical, especially supporting structures. The runout zone offers some possibilities for the installation of retarding structures. Whether such control is possible can be answered only by a detailed study of the frequency of occurrence and the terrain conditions in the runout zone.

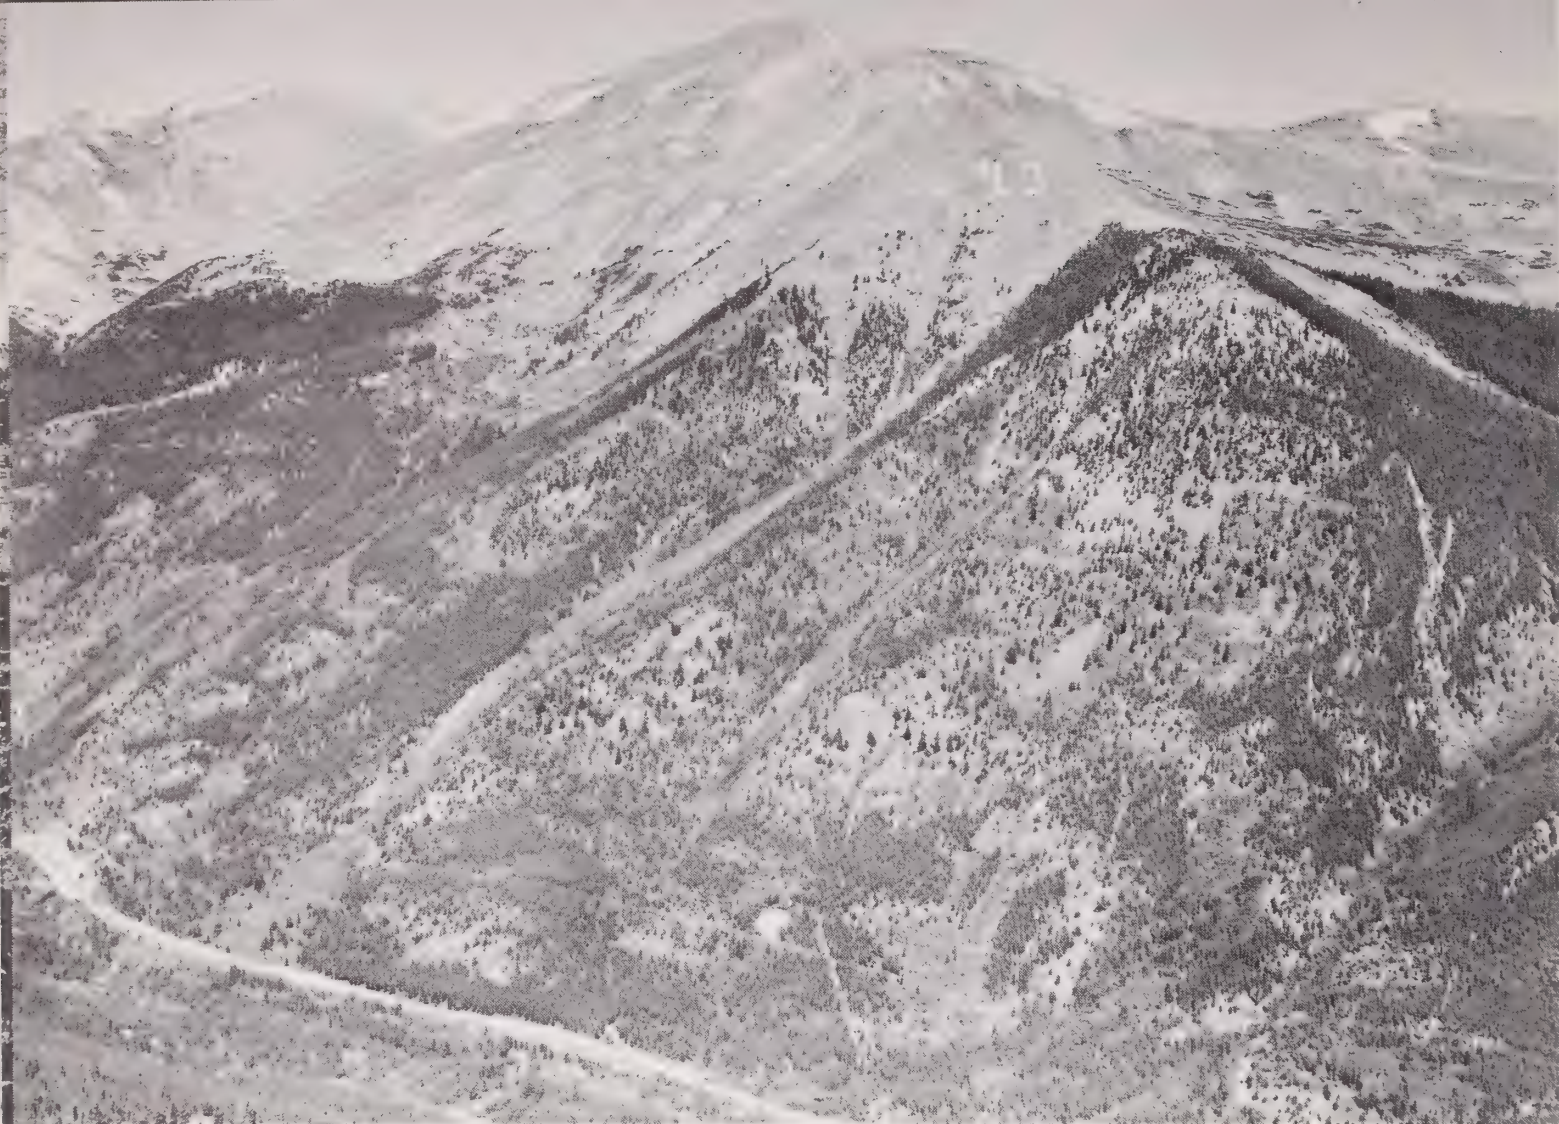
BARD SHOULDER (L-3)

Highway No. 6 --
Loveland Pass
Photo: September 1, 1962

The ruggedness and steepness of the catchment basin, together with the excessive snow accumulations (drifts), create some problems for supporting structures. Two diversion dams already installed, are not always effective because the runout zone is too steep and the dams too small. Control measures either in the track or in the runout zone are out of the question if full protection is expected from all avalanches. Only very expensive supporting structures or an avalanche shed would give full protection to the road. Guide walls parallel to the avalanche track could be used with an avalanche shed to shorten the length of the expensive shed.

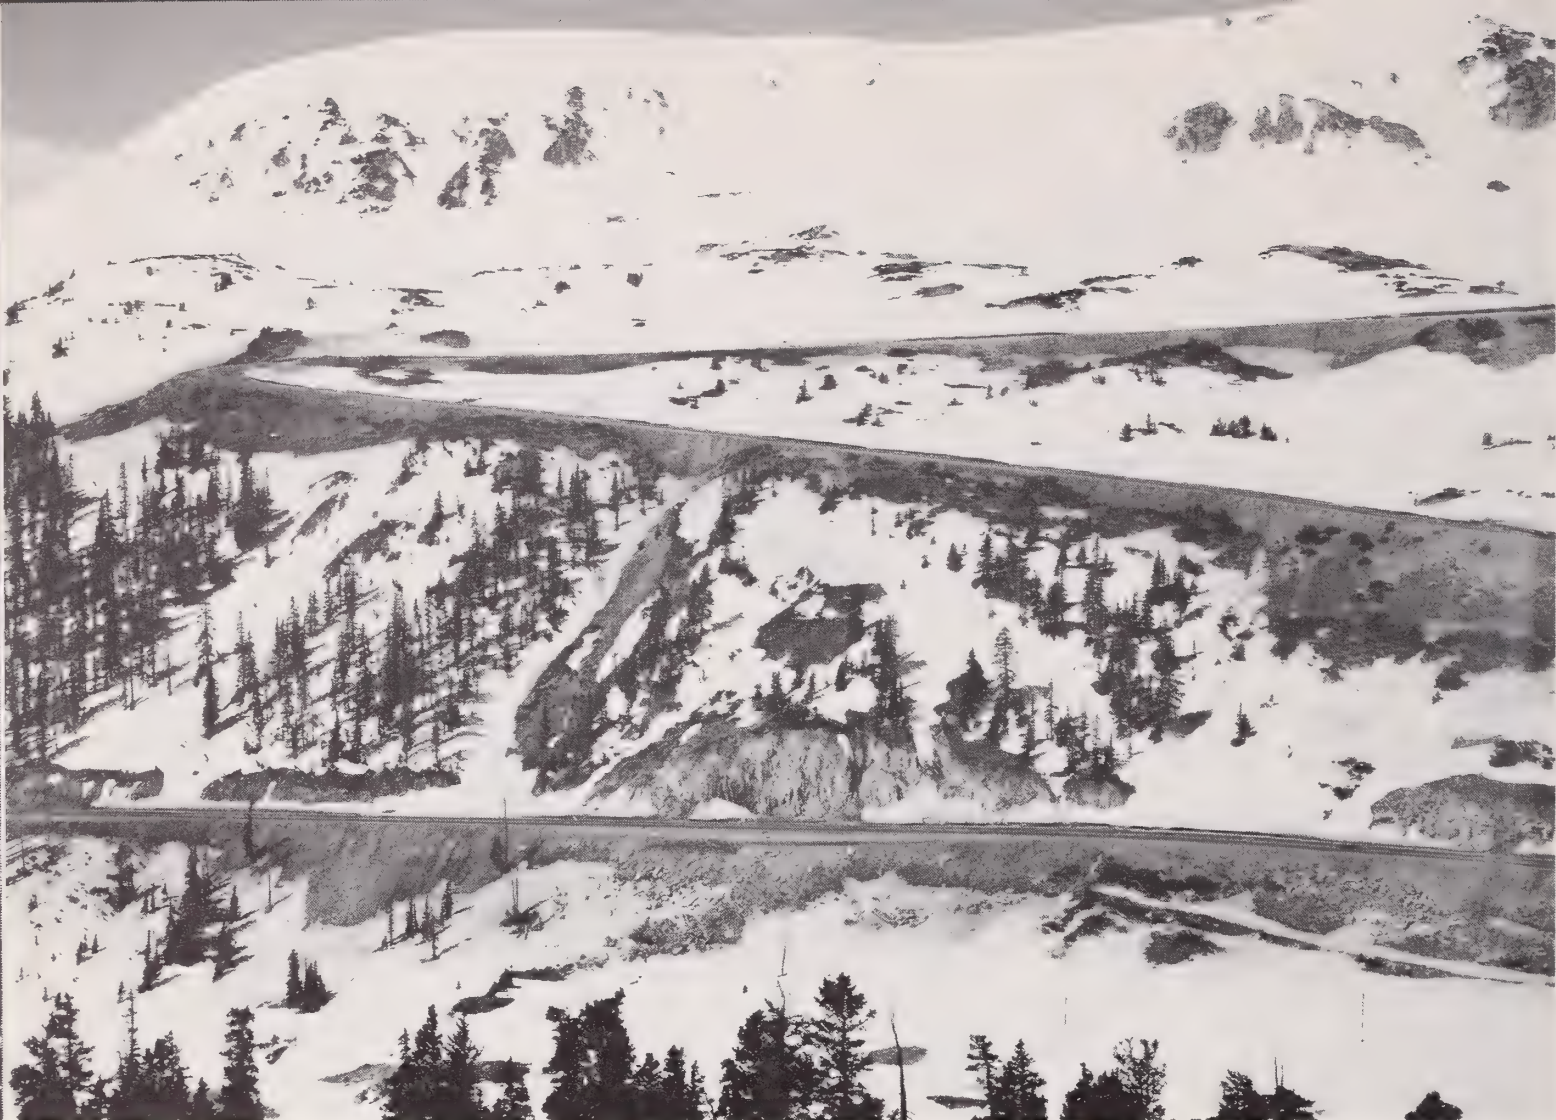
FIVE CAR (L-7)

Highway No. 6 --
Loveland Pass
Photo: May 11, 1962

Control is not urgent, but if it is desirable to protect the highway, terrain conditions are rather favorable for a diversion dam in the runout zone. Control in the starting zone is out of the question because it is too big and rugged.

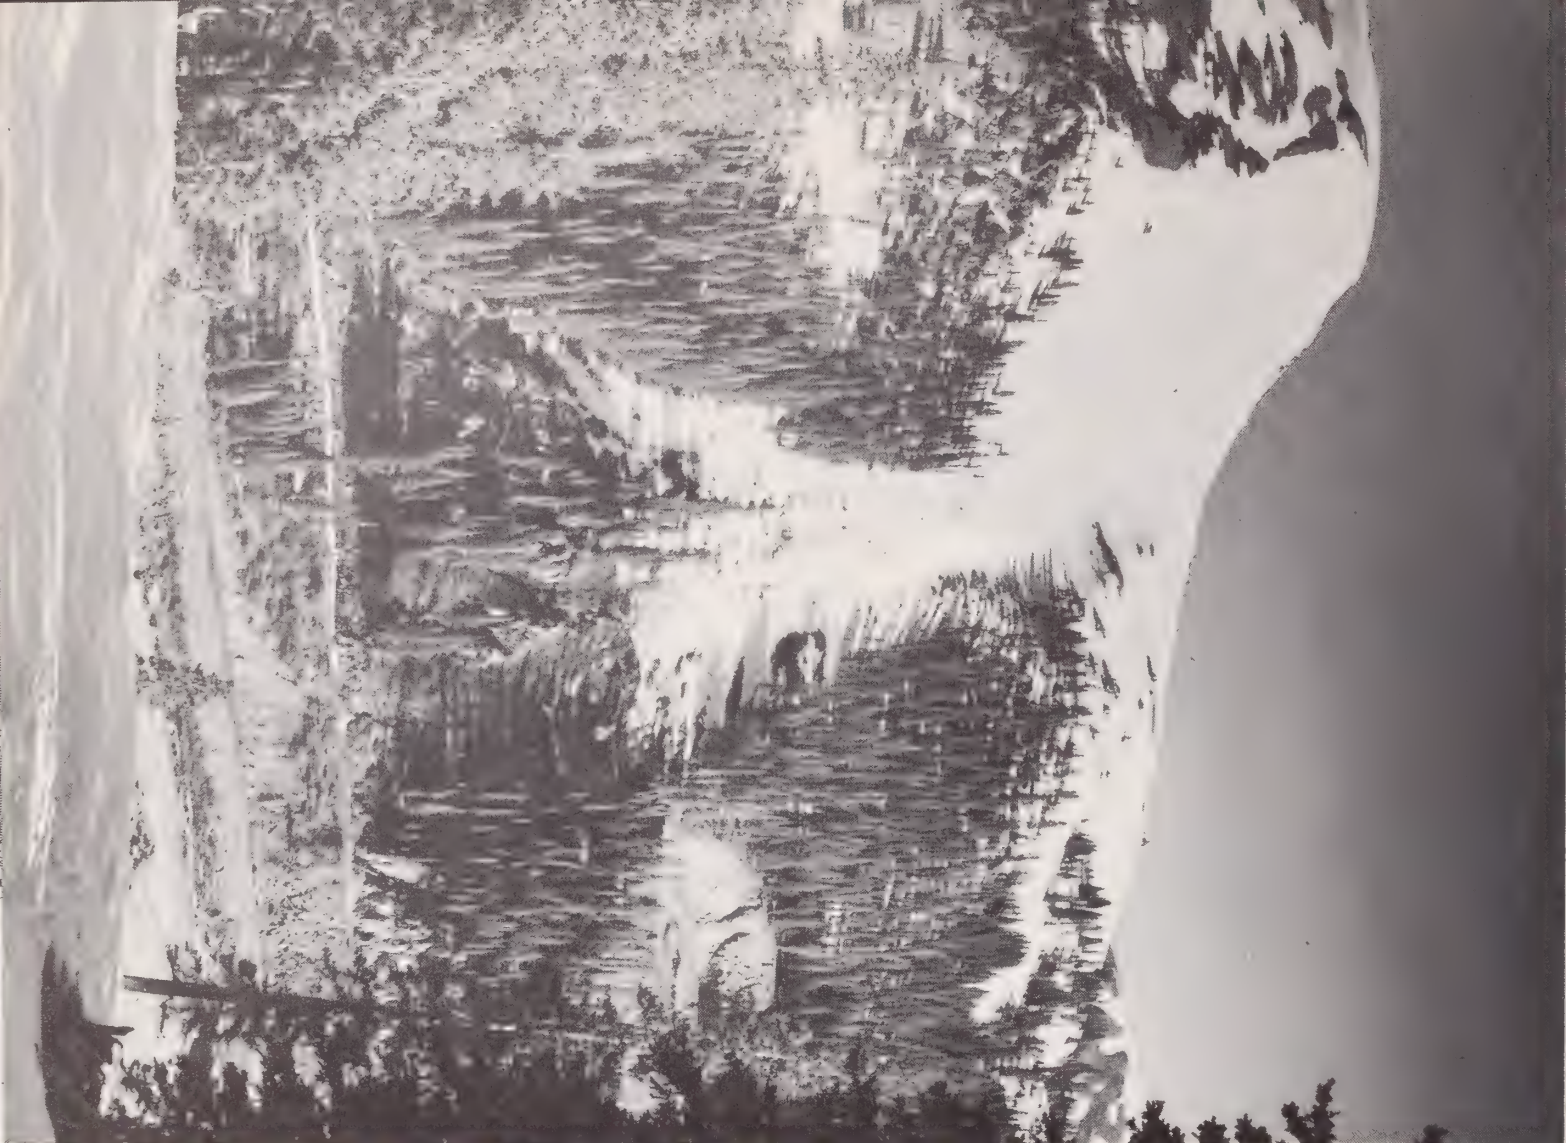
ASSOCIATED LITTLE PROFESSOR
(OR CLIFF) (L-10)

Highway No. 6 --
Loveland Pass
Photo: May 11, 1962

Since the starting zone shows a tendency to erode by rockfall, its stabilization should be studied. Except for the unstable ground and some very steep spots, there are no difficulties for control with supporting structures. Afforestation would be the most important control measure.

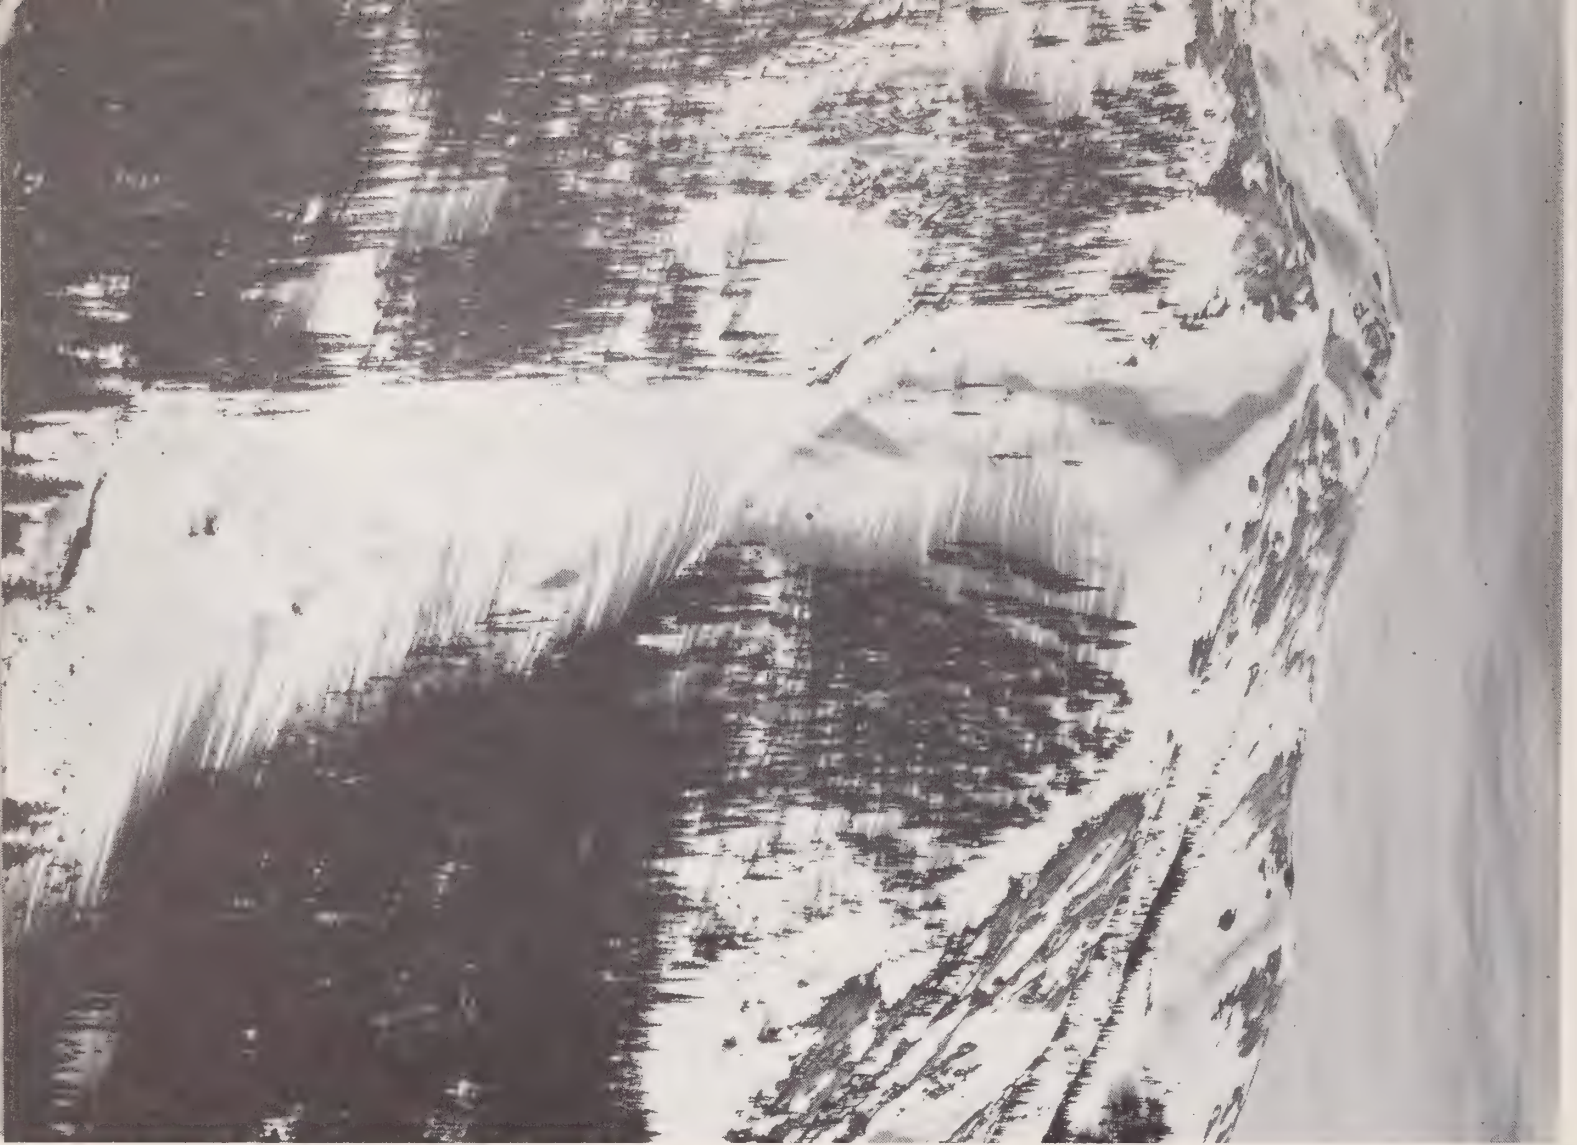
PALAVICINI (L-11)

Highway No. 6 --
Loveland Pass
Photo: May 9, 1962

Terrain and vegetation conditions would be favorable for control by supporting structures; however, structural control is out of the question because of ski use of this avalanche track.

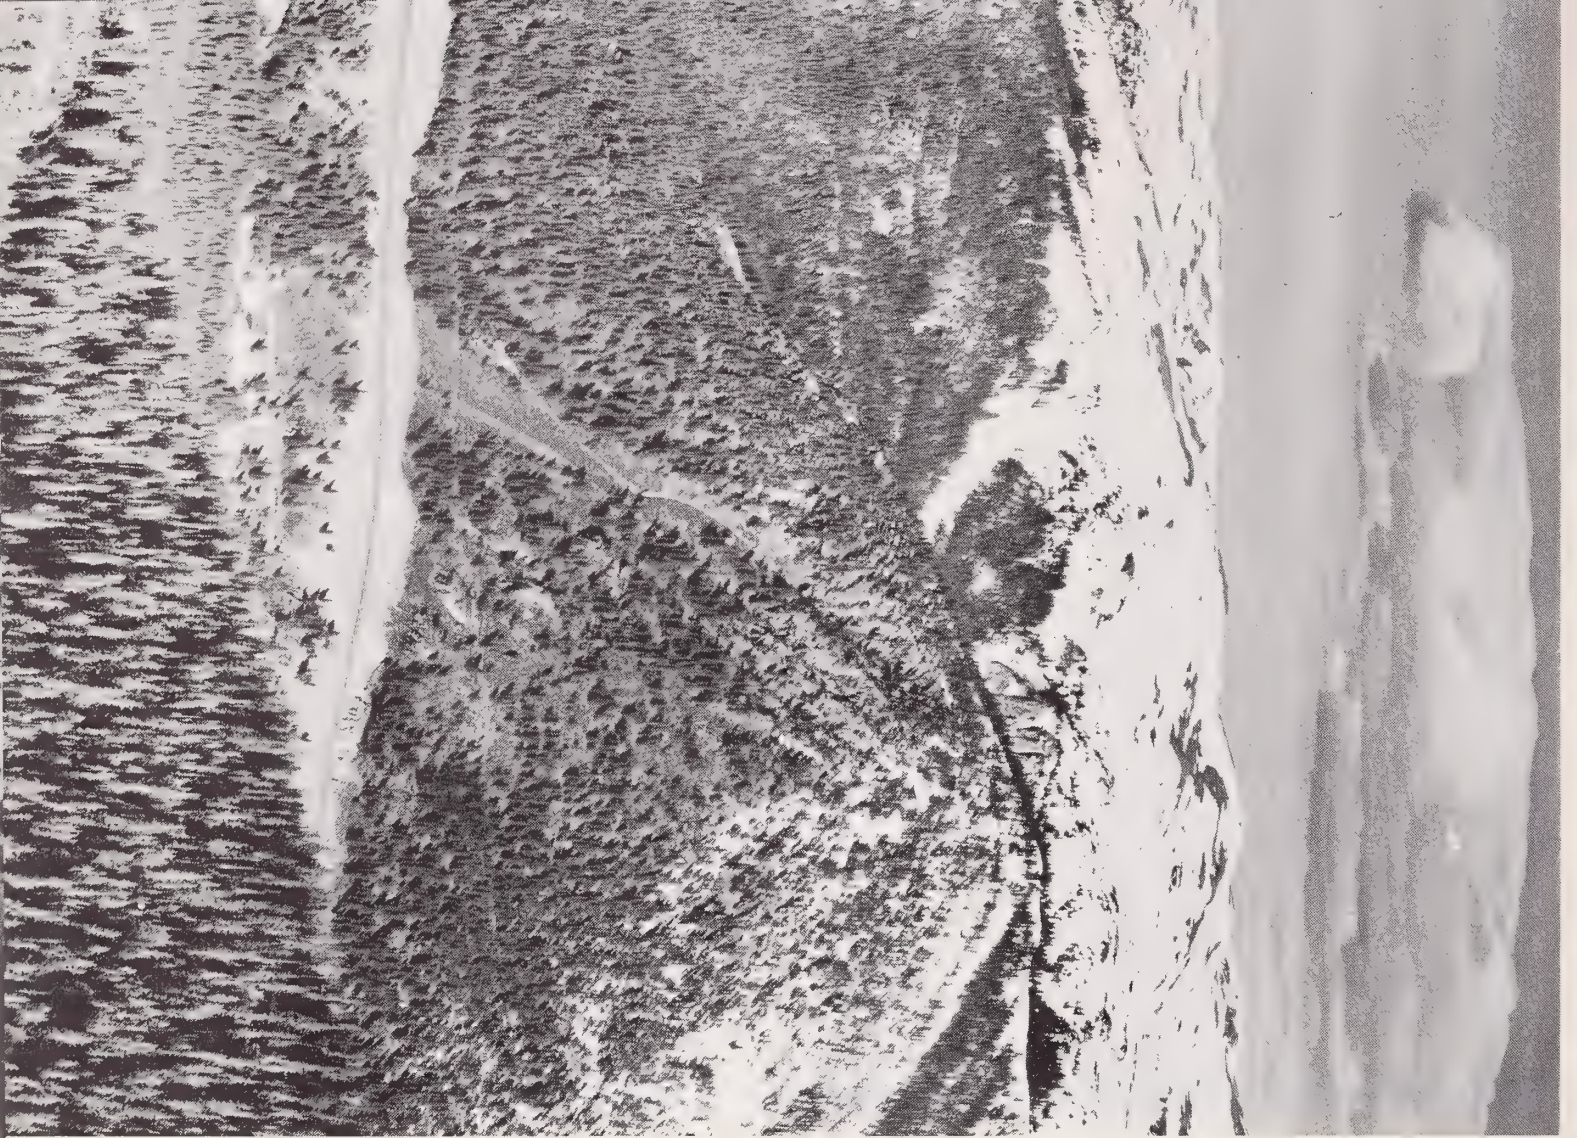
HAPPY END (OR FINGER) (L-13)

Highway No. 6 --
Loveland Pass
Photo: May 11, 1962

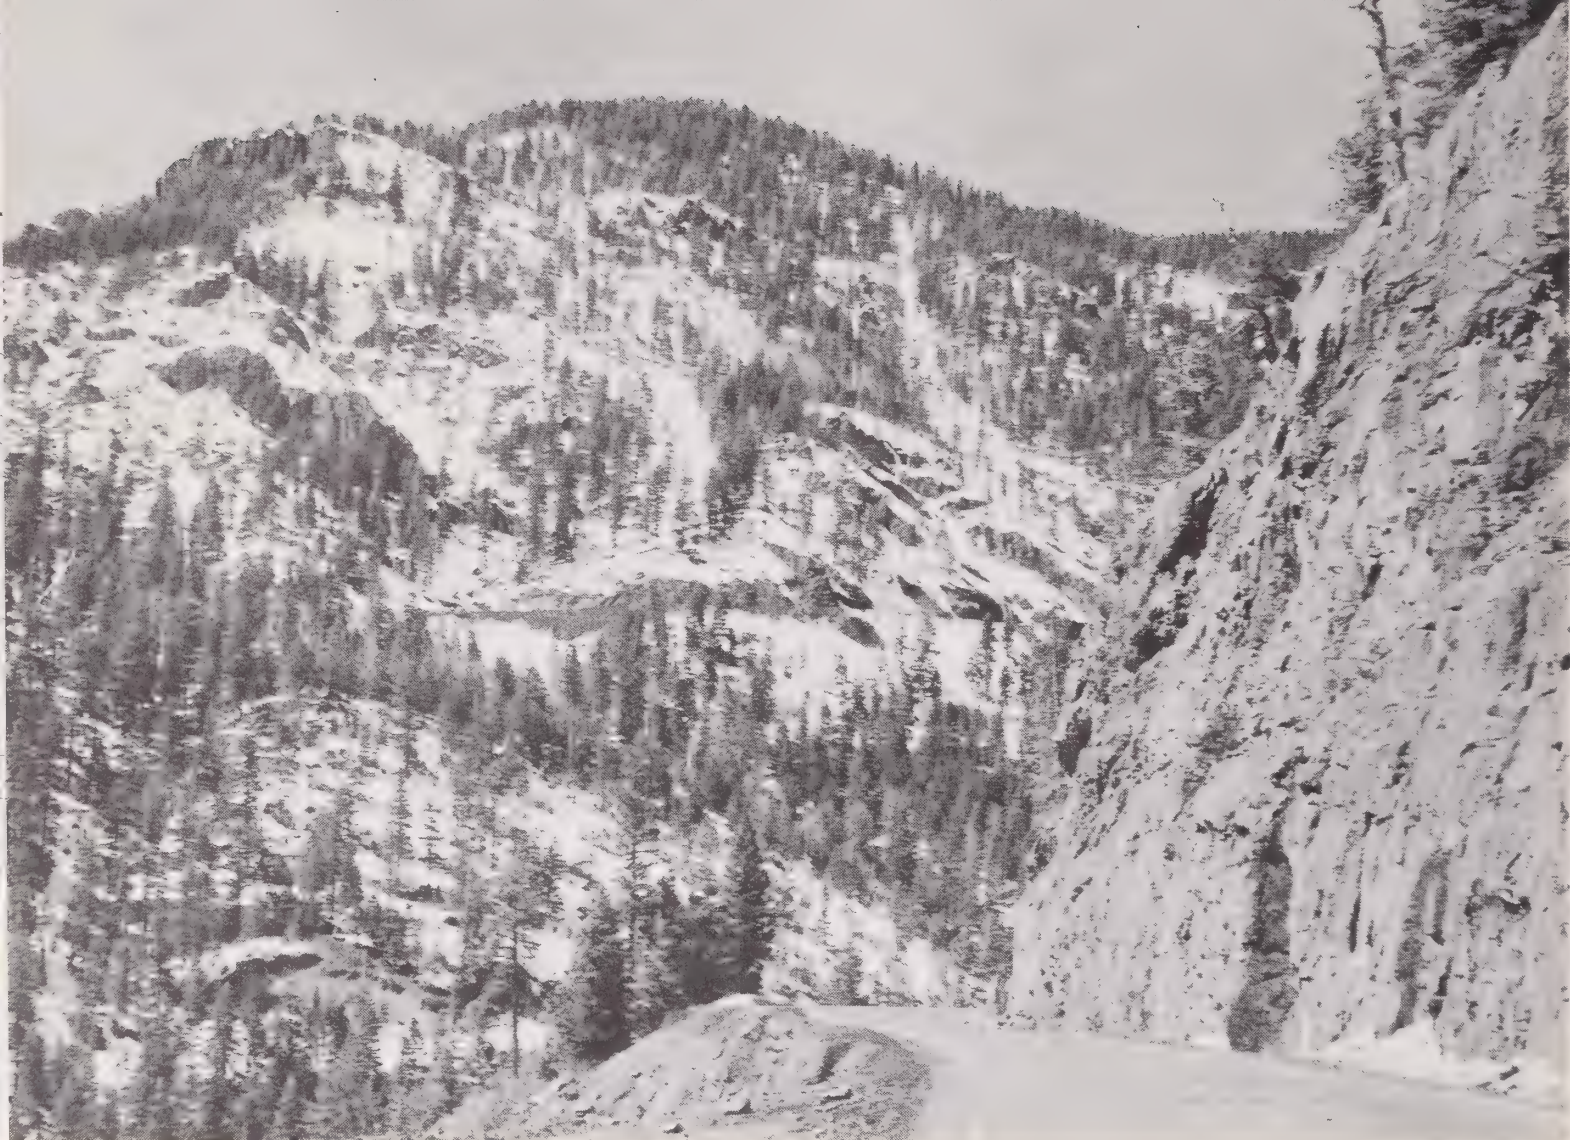
SWITCHBACK (W-2)

Highway No. 160 --
Wolf Creek Pass
Photo: March 26, 1962

Control of starting zone, including afforestation, is most obvious.

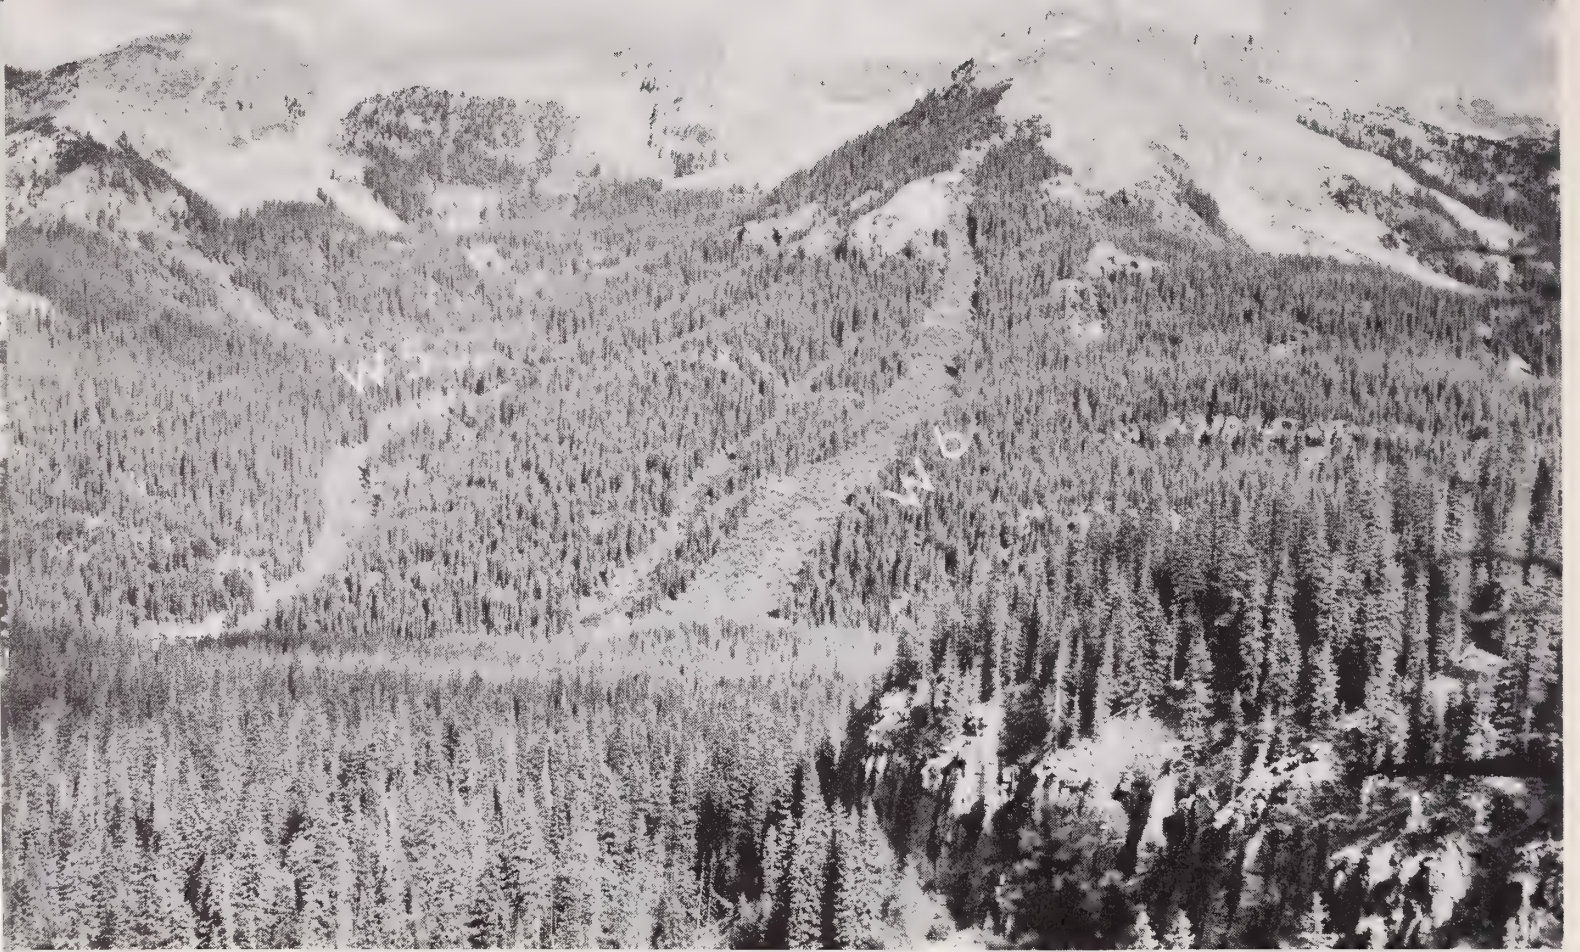
CAMP (W-5)

*Highway No. 160 --
Wolf Creek Pass
Photo: July 5, 1962*

Control of starting zone is probably most economical control measure. Since whole track lies on timbered slope, afforestation would be an integral part of project.

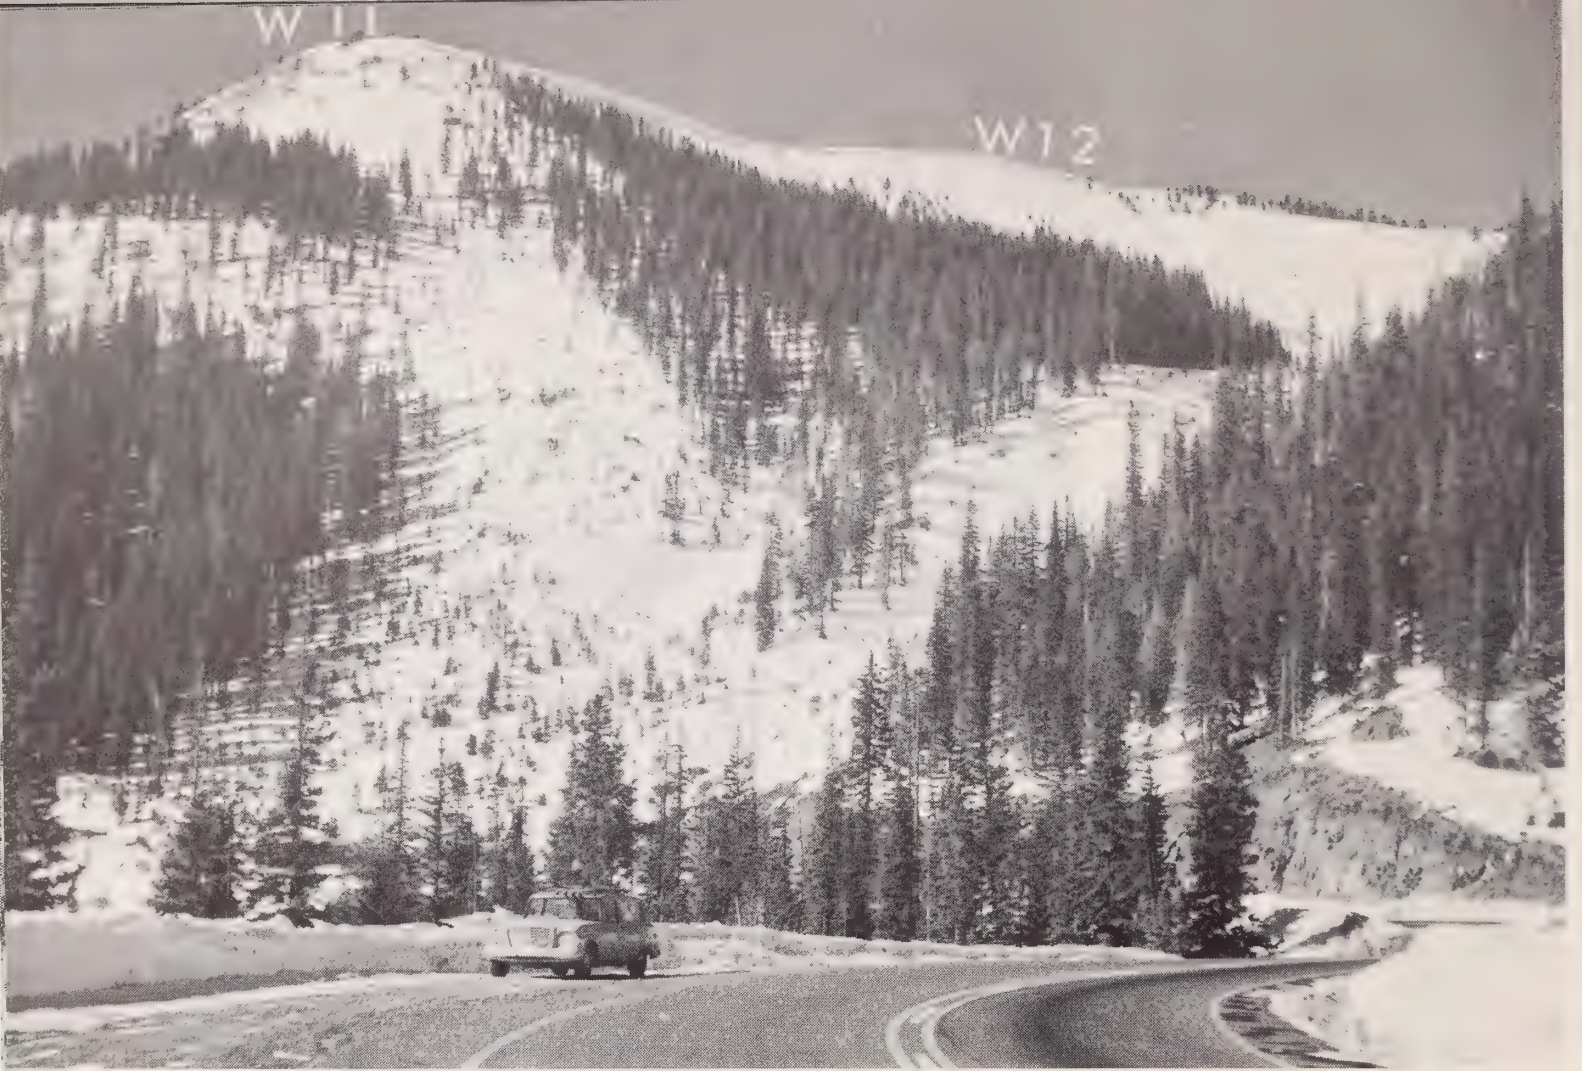
ALBERTA (W-11)

Highway No. 160 --
Wolf Creek Pass
Photo: January 5, 1962

Starting zone can be controlled with supporting structures. No technical difficulties; forest will later replace almost all structures.
